Crash of the Polish Governmental Plane PFL 101 in Smolensk¹

April 10, 2010

Status Report Dated November 11, 2011²

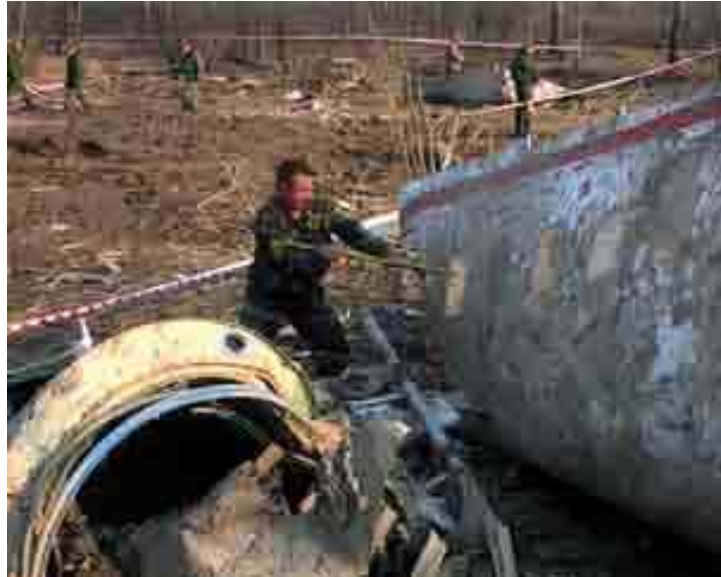
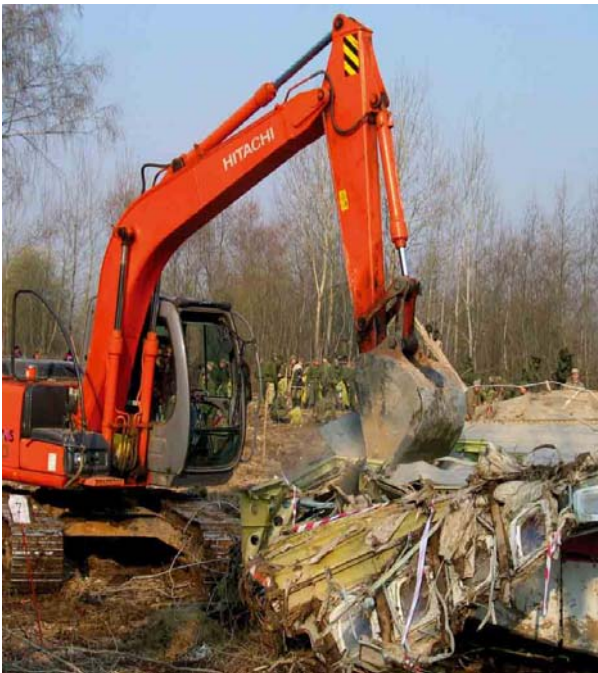
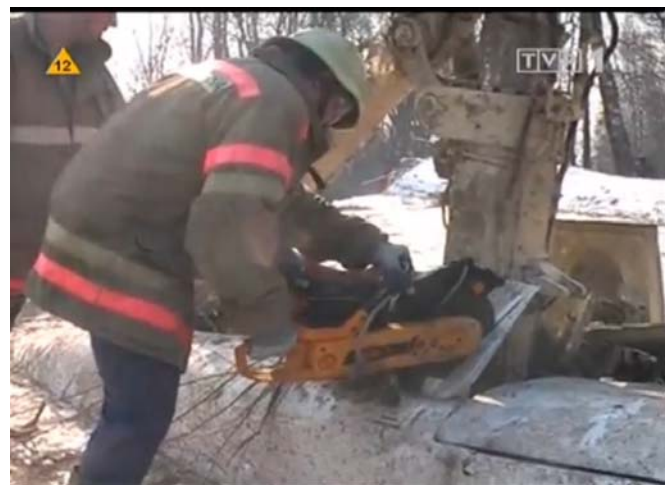
Photos Taken at the Scene of the Smolensk Crash on April 11, 2010⁷⁴

Appendix 1: Destruction of Evidence
