The University of Akron
College of Polymer Science
and Polymer Engineering

LESSONS LEARNED

September 2017 – Multiple Fire Near Misses

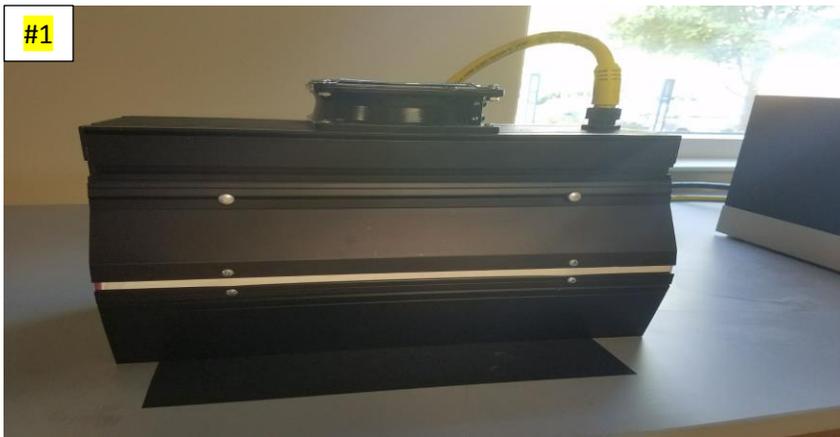
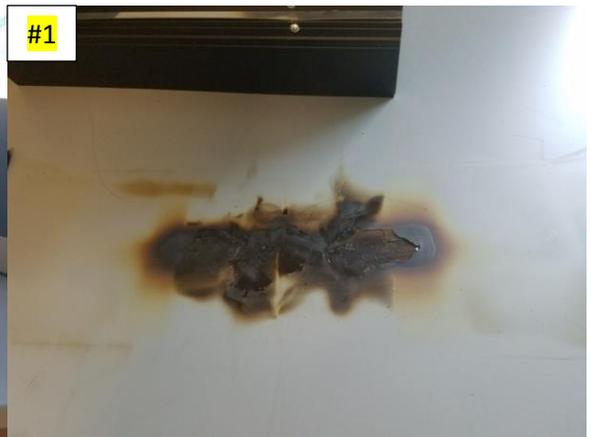
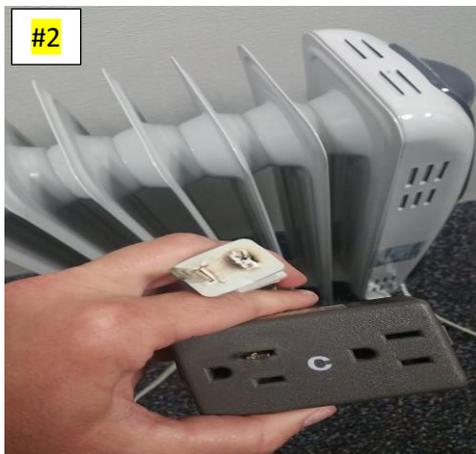
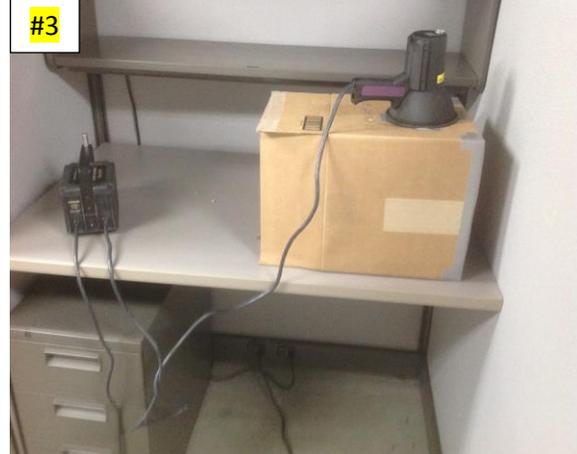
1. UV exposure experiment placed on top of combustible black paper intended to absorb the stray light, was left unattended for only 15 minutes and initial stages of smoldering began. The experiment was set up outside of a hood without a UV light protection box with the power of the UV lamp underestimated by the researchers.
2. Portable heater left running unattended. Power draw from the heater on the outlet too much and melted the plug into the outlet. If not found by safety, would have eventually started a fire.
3. Not associated with #1, a UV curing box made from combustible material, without UV protected box was found by Safety. No immediate threat of fire, but the potential was there. This was also completed outside of a hood in a room intended for storage with no sprinkler system.

1. Underestimation of the UV lamp power due to the UV lamp being new equipment.
2. Portable heater needed more power than outlet could provide.
3. Unsafe UV curing box made with combustible material.

1. UV lamp was new equipment and researchers not aware of UV potential.
 - a. Experiment was set up in unsafe location due to accessibility of a 220 outlet.
2. Portable heater left running while unattended.
3. Experiment set up was a fire risk and located in an unsafe location.

1. Researchers working with machine shop to build appropriate UV box and Safety Officer is finding a safer location with a hood for the experiment. UV Radiometer is being used to estimate the UV dosage and black UV absorbing paper is being replaced with UV absorbing acrylic sheet.
2. Heater has been removed and safety awareness email sent to CPSPE.
3. Combustible box has been removed, and group given the option to seek out alternatives with machine shop.

1. Learn all of the functions of new equipment.
 - a. Seek out the Director of Operations and/or Safety for new experiment/equipment needs and risk assessment.
2. Remove all portable heaters from CPSPE. It is against the Ohio fire code and the air temp is returning to normal.
 - a. If used at home, do not leave heaters running while unattended or sleeping.
3. Please seek out the Safety officer with handmade experiments for risk assessment. If the experiment works, it does not mean it is done in the safest manner.
